SPIRIT OF SUTTERBY PROJECT

ANALYSIS AND DISCUSSION OF THE WEST WALL OF SUTTERBY CHURCH

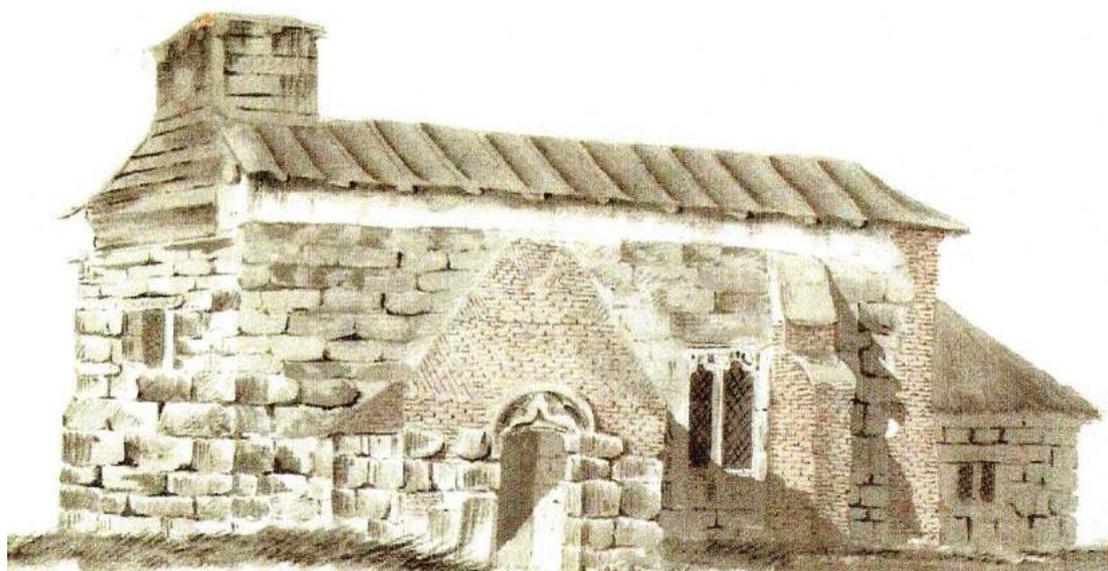
Figure 1. Drawing of Sutterby Church in 1790 by John Claude Nattes
Image courtesy of Lincs to the Past, ref Nattes/4/79

- Nattes shows brick repairs in the fabric of the church but does not show the brick levelling course or any other brick repairs in the west wall. It could, therefore, be assumed these were incorporated post 1790, however, the brick course makes little visual impact on the wall and we cannot assume that Nattes would have bothered to show it.

- Nattes shows the church roofed in lead with a shallow pitch. The south nave wall appears higher, and was presumably lowered when the roof pitch was increased and the brick gables constructed. The original west gable and the belfry appear to be clad in boards and are probably constructed of timber. The limestone string course (see Appendix 2) which now levels the top of the stone wall and forms the base of the current brick gable is not evident and thus must have been added post 1790.

- The west window is shown centrally in the west wall, but is significantly higher than the present window (six courses of stone below it; now four courses of stone, c.f. Fig 2). This may indicate a substantial rebuild of the west wall after Nattes's drawing was made, which would be consistent with the appearance of the brick repairs. However,

it may be purely artistic licence - the artist's perspective of the relationship of west to south sides is distorted to maximise the view of the church. There is a hint of moulding visible on the north jamb of the window similar to the current moulding but no mullion is shown.

- Nattes appears to depict a chamfer some five course up from the ground (visible on the NW corner). This is intriguing as there is no chamfer at this level today. There is a chamfer at ground level (see Phase 1 in Figure 9 and Appendix 1) and a fragment/remnant of chamfer on the north west corner some eight courses up and level with the top of the present window. However, this is probably spurious as it is considered that this fabric forms part of a later repair to a collapsed north west corner (see phase 4b below and Fig. 9).

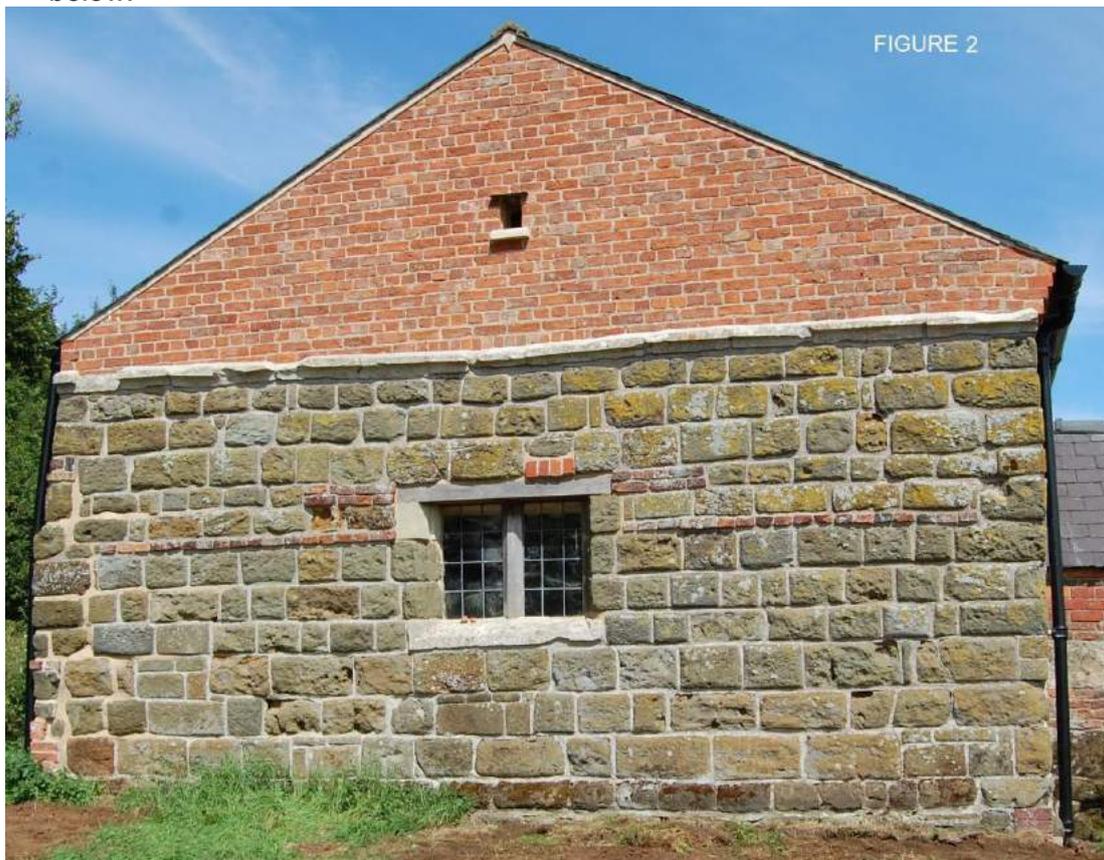
Figure 2. The west wall of Sutterby Church

- 2.4 **Phase 1**, the lowest part of the wall, is characterised by darker sandstone and irregular blocks and is topped by a chamfered course. The chamfered course is much eroded and damaged. It has an average projection of 7.5 cms. The chamfer angle is worn and variable but averages 50° (see Appendix 1). It is probable that this fragment of the wall survives from the final rebuild/shortening of the west end. The blocks are irregular and look reused. It is remarkable (and perplexing) that the chamfer blocks

- 2.5 **Phase 2** is a rebuild of the main body of the west wall up to and including the sill and lower jambs of the window - the stone is cut in regular blocks with good coursing and is greener than the phase 1 stone. The sill of the window is limestone (two pieces) but the jambs (except for the recently replaced section) are in sandstone. (see Figs 7a/7b).

- 2.6 **Phase 3** begins with a levelling course of hand-made brick and includes brick coursing each side of the window lintel. The stone is similar in form and coursing to that of phase 2. It is possible that phases 3 and 2 are of the same build with the brick used to adjust levels to fit a pre-existing window frame. Phase 3 terminates under the limestone string course.

- 2.7 **Phase 4a** is defined by a vertical track of discontinuity in coursing, irregular block sizes and broken/reset stones. It may be the result of a rebuild of the south west corner of the church. Conversely, it may be contemporary with phases 2 and 3 but be the result of masons trying to incorporate the stub of the standing south wall into a west wall rebuild. The south wall has not yet been surveyed, however a brief examination of the south west corner suggests the rebuild theory is probable (see Fig. 3 below).

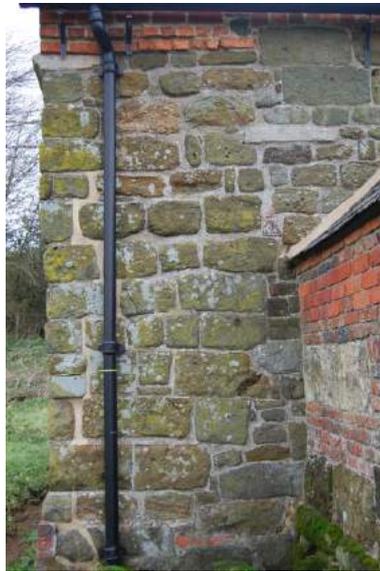
Figure 3. The south west corner of Sutterby church. Although this wall has yet to be surveyed and analysed, a brief inspection suggests that the corner may have been rebuilt. However, the complex sequence of construction around the porch and south door is not yet drawn and analysed.

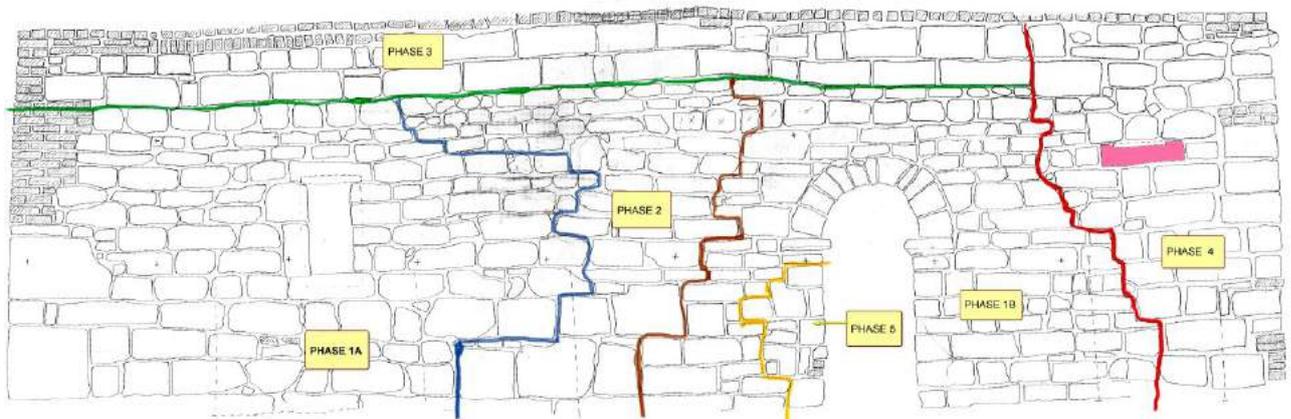
- 2.8 **Phase 4b** is defined by a vertical track of discontinuity in coursing and is thought to represent a collapse and rebuild of the north west corner of the church. A survey of the north wall of the church carried out in 2014 identified a corresponding rebuild phase at the west end of the north wall which would be in accord with this suggestion. See phase 4 of the north wall sequence shown at Fig 4 below.

Figure 4. Phasing plan for the north wall of Sutterby Church - note phase 4

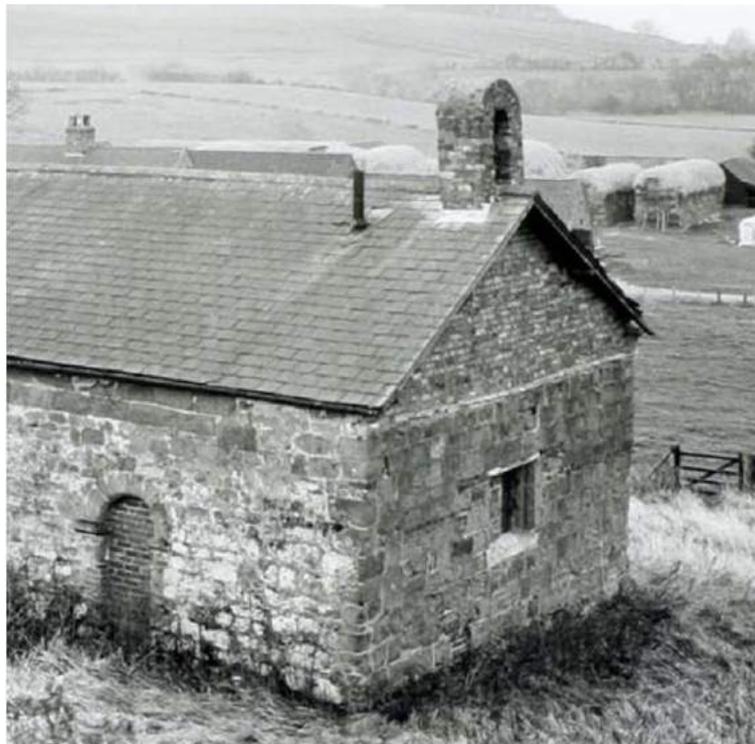
This string course is not shown in Nattes's 1790 drawing of the church (Fig. 1) but at some point after that date, and presumably when Welsh slate had become readily available as a roofing material (probably following the introduction of the railways to Lincolnshire in 1848) the lead roof and timber clad gable depicted by Nattes were replaced with a slated roof and brick gable. This entailed steepening the pitch of the roof by reducing the height of the nave walls, and rebuilding the west and east nave gables. The work incorporates larger format, machine-made bricks which probably date from the mid to late nineteenth century. It would be fair to guess that this re-roofing of Sutterby church took place around the 1870s. The timber belfry was probably replaced by the arched brick bellcote at the same time.

Figure 5. Photograph of Sutterby church from the north west taken in November 1963, showing the limestone string course, the first brick gable and the arched brick bellcote at the west end
(Photo from Historic England Archive Ref: 2826/43)

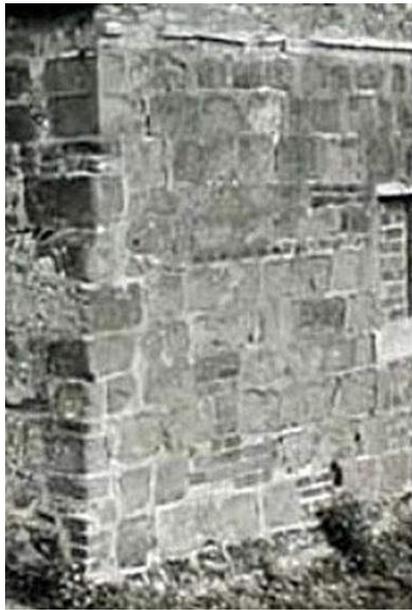
2.11 **Phase 7** is a series (four shown) of areas of stone replacement - at first sight, these are straightforward replacements of perished stone, however, it seems from the detail from the Historic England Archive photograph 2826/44 shown at Fig. 6, that

Figure 6. Detail from RCHM photo 2826/44 showing areas of brick repair in west wall - later replaced in stone.
(Photo from Historic England Archive Ref: 2826/44)

in 1956, these areas appear originally repaired in brick. The replacement of the brick was carried out before 1996, when architect Peter MacFarlane (of Bond and Reid in Grantham) comments: ' ...in recent years the walls had been well, and fairly extensively repaired ...'.

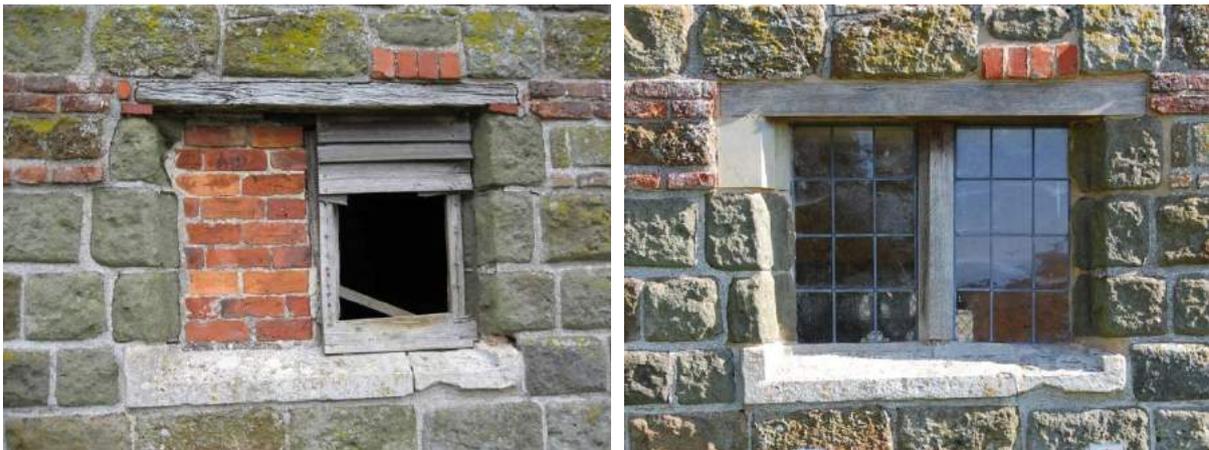
2.12 **Phase 8** comprises the replacement of the upper stone of the northerly window jamb, together with the fitting of a new timber lintel and mullion. This work was carried out by Anderson and Glenn (Architects) as part of a larger programme of repairs in 2010/2011. Their condition report on the church (August 2011) shows the west window prior to repair (See Figs 7a and 7b, below)

Figures 7a and 7b. The west window of Sutterby Church before and after repair

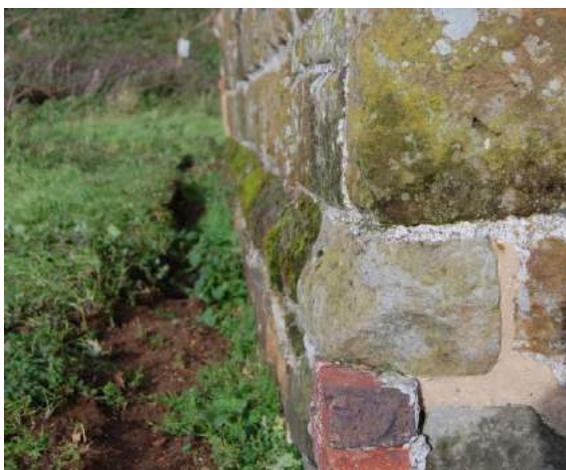
Photograph of the chamfered course viewed from SW corner of church, looking north (moss covered course).

The chamfer course is much worn. It has an average projection of 7.5 cms. The chamfer angle is worn and variable but averages c. 50°

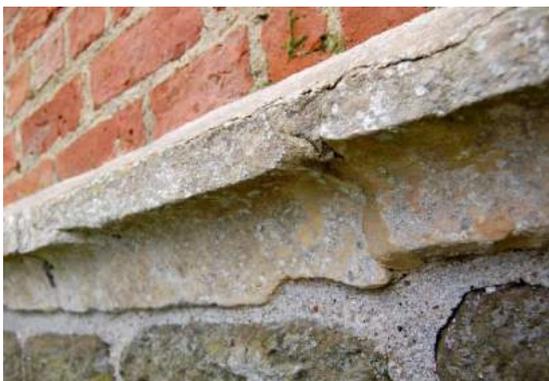
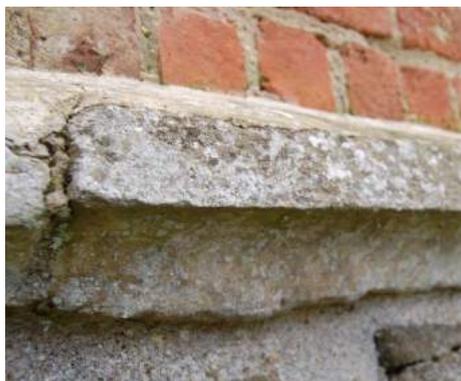
The stonework of the west wall is topped with a limestone hollow chamfer string course. It is made from a fine grained oolitic limestone and appears to have been added as a levelling course at the same time as the gable was rebuilt in brick, probably in the mid to late nineteenth century. There is nothing similar elsewhere in the fabric of Sutterby church and it is probable that it has been brought in from elsewhere and reused. The moulding is much damaged and some areas show evidence of reworking, particularly its northernmost stone, which has had an area crudely cut away. The position of the moulding may be seen in Fig 2 of the west wall report. Detailed photographs are shown below:
