SPIRIT OF SUTTERBY PROJECT

ANALYSIS AND DISCUSSION OF THE WEST WALL OF SUTTERBY CHURCH

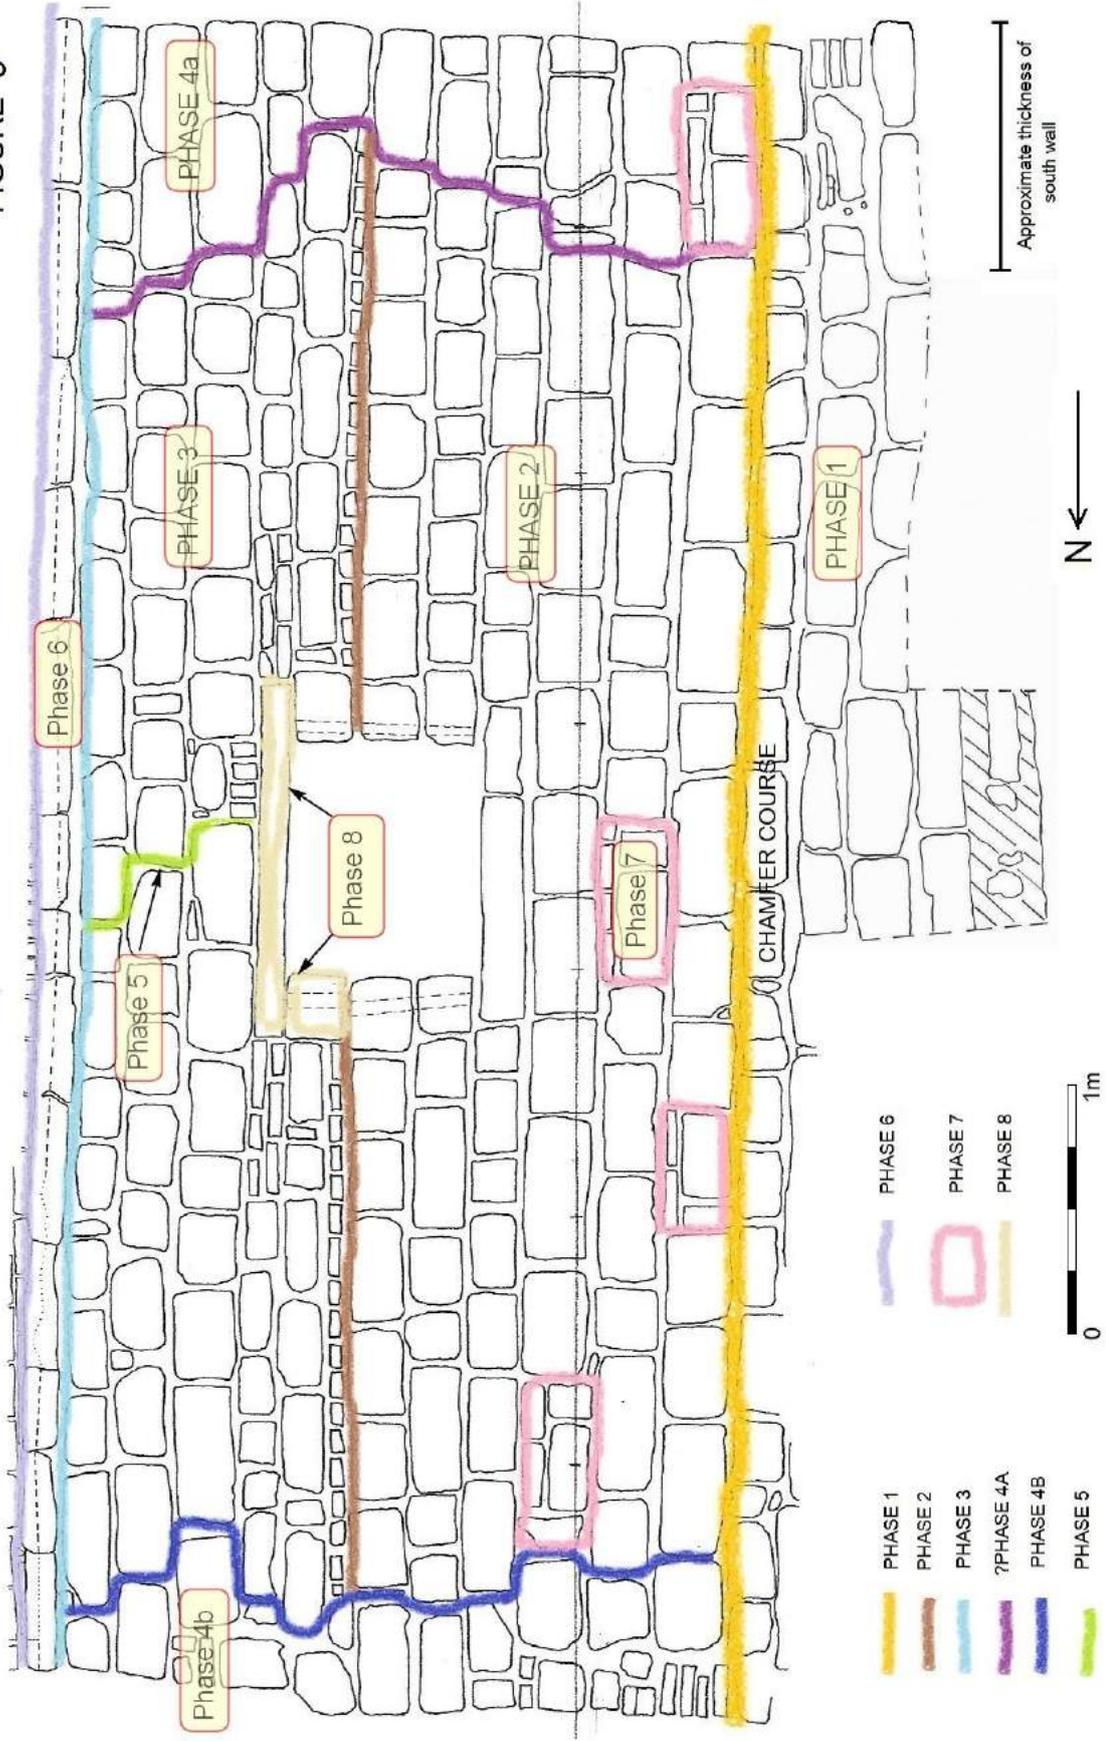
FIGURE 9

- Nattes appears to depict a chamfer some five course up from the ground (visible on the NW corner). This is intriguing as there is no chamfer at this level today. There is a chamfer at ground level (see Phase 1 in Figure 9 and Appendix 1) and a fragment/remnant of chamfer on the north west corner some eight courses up and level with the top of the present window. However, this is probably spurious as it is considered that this fabric forms part of a later repair to a collapsed north west corner (see phase 4b below and Fig. 9).

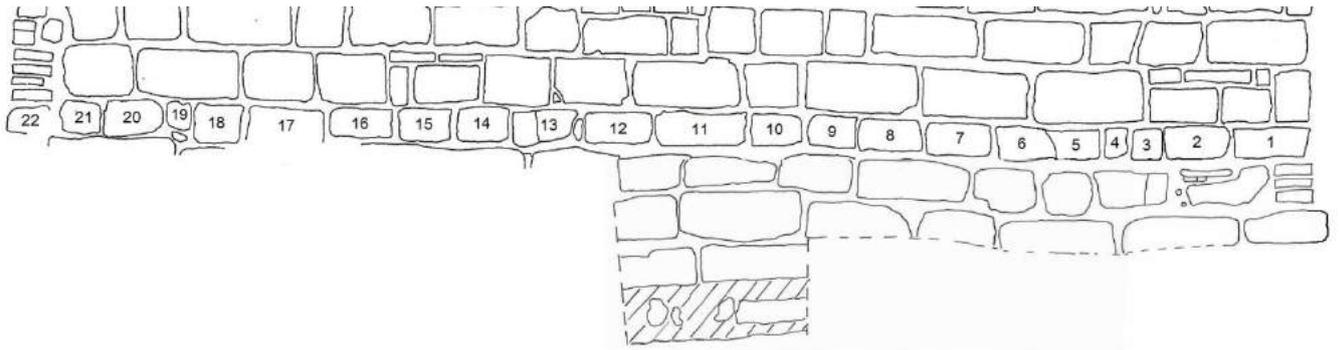
SUTTERBY CHURCH WEST WALL CHAMFER COURSE DESCRIPTION

N ^o .	Comment	cms	N ^o .	Comment	cms	N ^o .	Comment	cms
1	worn chamfer	5	9	quite good chamfer	8	17	good chamfer, long	9
2	worn chamfer	5	10	quite good chamfer	10	18	damaged chamfer	4
3	'dropped' worn chamfer	7.5	11	long; worn base	9	19	damaged - no chamfer	-
4	very worn chamfer	4	12	good chamfer - worn below	10	20	damaged chamfer; scored	7
5	all one stone worn	9	13	fragmentary - poss worn chamfer		21	damaged chamfer - scored	7
6			14	quite good chamfer	8	22	damaged, fragmentary. Prob once chamfered	-
7	good chamfer	7	15	good chamfer	8			
8	good chamfer	8	16	good chamfer, base worn	6

The measurement shown (cms) is the projection of the chamfer from the wall above (i.e. the amount the chamfer course projects beyond the upper courses)

The chamfer course is much worn. It has an average projection of 7.5 cms. The chamfer angle is worn and variable but averages c. 50°
